Re: June 2013 Monthly Progress Report  
Administrative Settlement Agreement and Order on Consent for Removal Action  
U.S. EPA Region 10 Docket No. CERCLA 10-2009-0255  
Gasco Sediments Site within the Portland Harbor Superfund Site

## Visual Observations Log Form

**Project Name:** NW Natural – Gasco

**Monitoring Period:** Monthly (Year 7)—June 2013

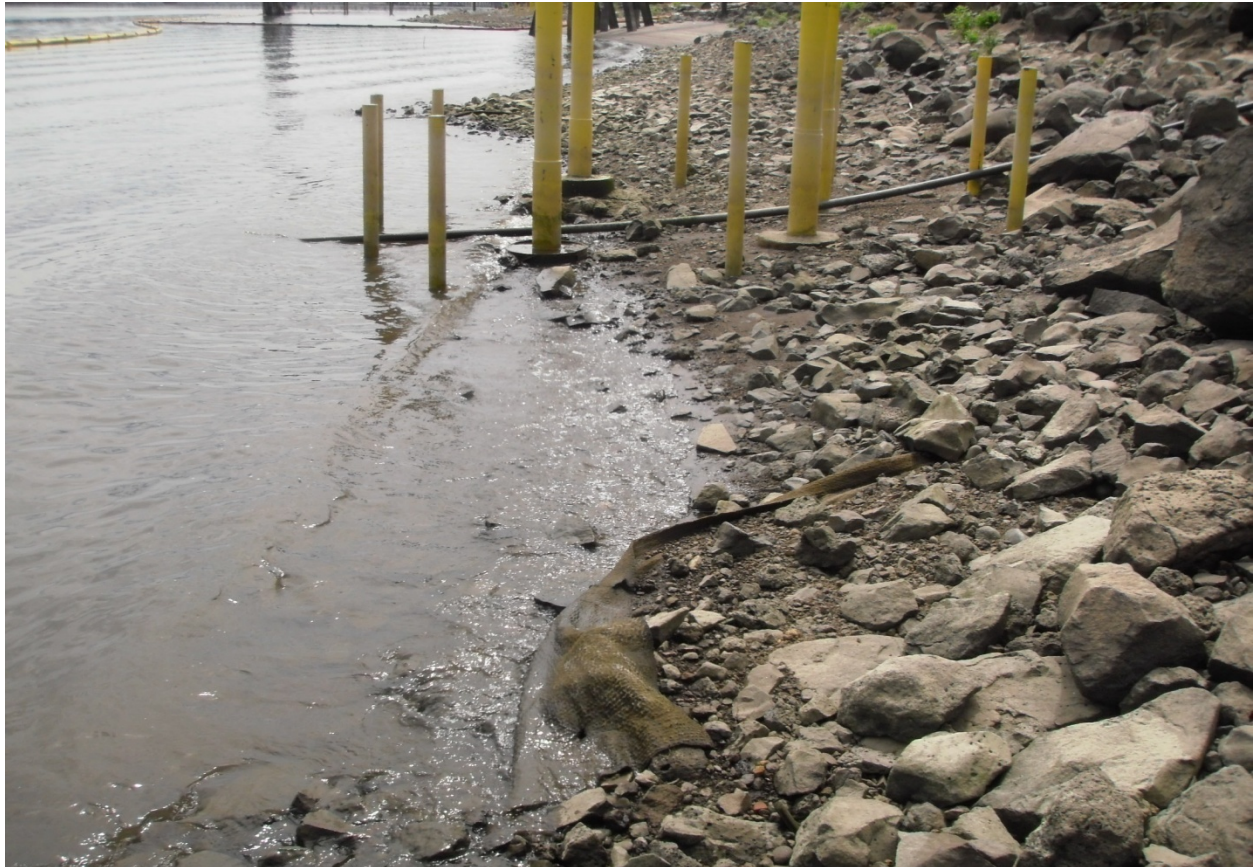
**Observations of Erosion/Deposition:** No erosion/deposition is evident along the shoreline. Three organoclay mat material segments are exposed and visible. Approximately 2 feet 20-foot section of organoclay mat is exposed shoreward of water's edge at the upriver extent of the cap area. A segment measuring 4-foot in length is exposed at the water's edge near the lateral mid-point of the cap area (Photo 1). One 40-foot section of organoclay mat material is exposed and submerged 0-3' below river surface at the downriver extent of the cap area.

Photo 1 — *Visible section of organo-clay mat at the lateral mid-point of the sediment cap (6/17/13):*

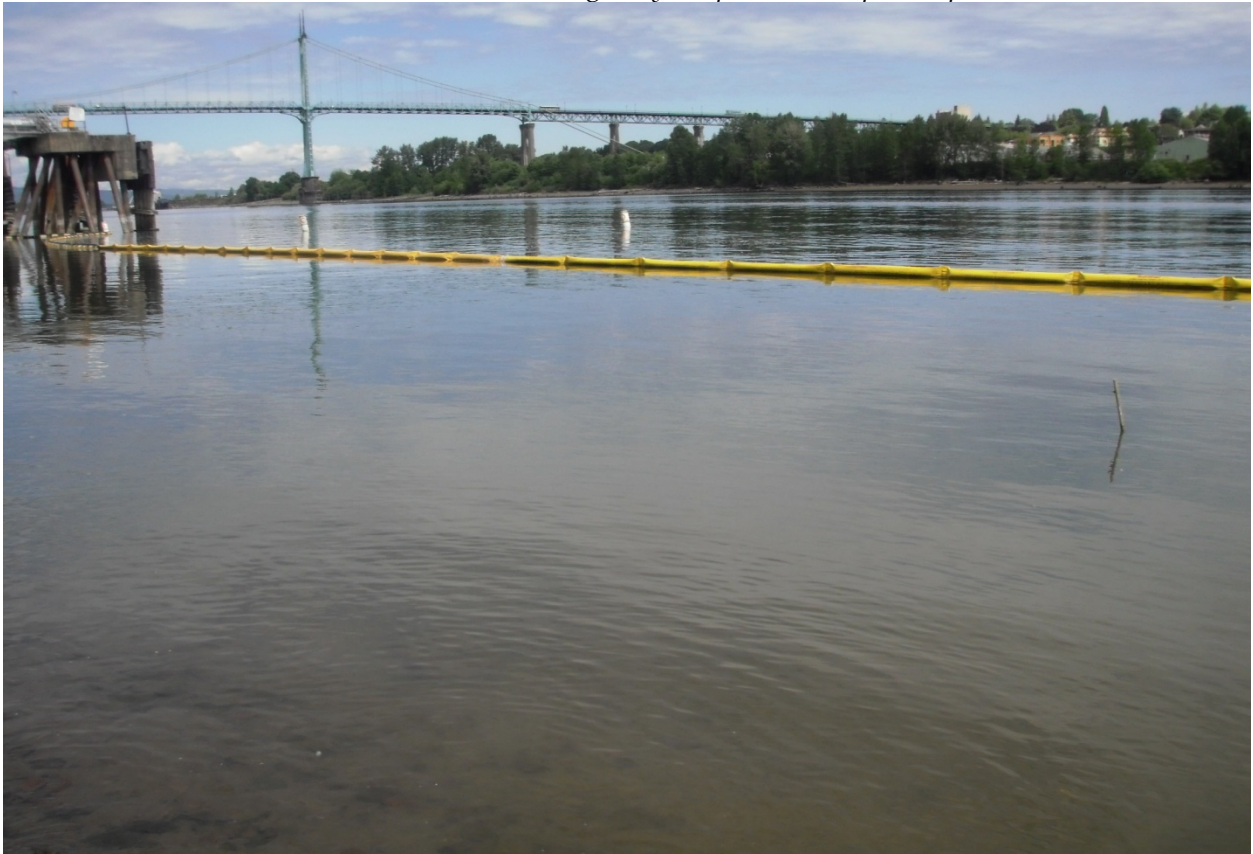
**Observations of Long-term Controls (i.e., oil booms, organo-clay mat, etc.)** During the observation, the Fuel and Marine Marketing (FAMM) containment boom was placed across the cap area, between the upriver corner of the ship dock and the wooden dolphin (near the upriver extent of the site and near the Siltronic Corporation outfall). Buoys that identify the cap area to mariners are in place as installed. The position of the FAMM oil boom, warning buoys, and a general overview is shown in Photo 2.

Photo 2 — *FAMM oil boom and mariner warning buoys in place across pilot cap area. (6/17/13):*

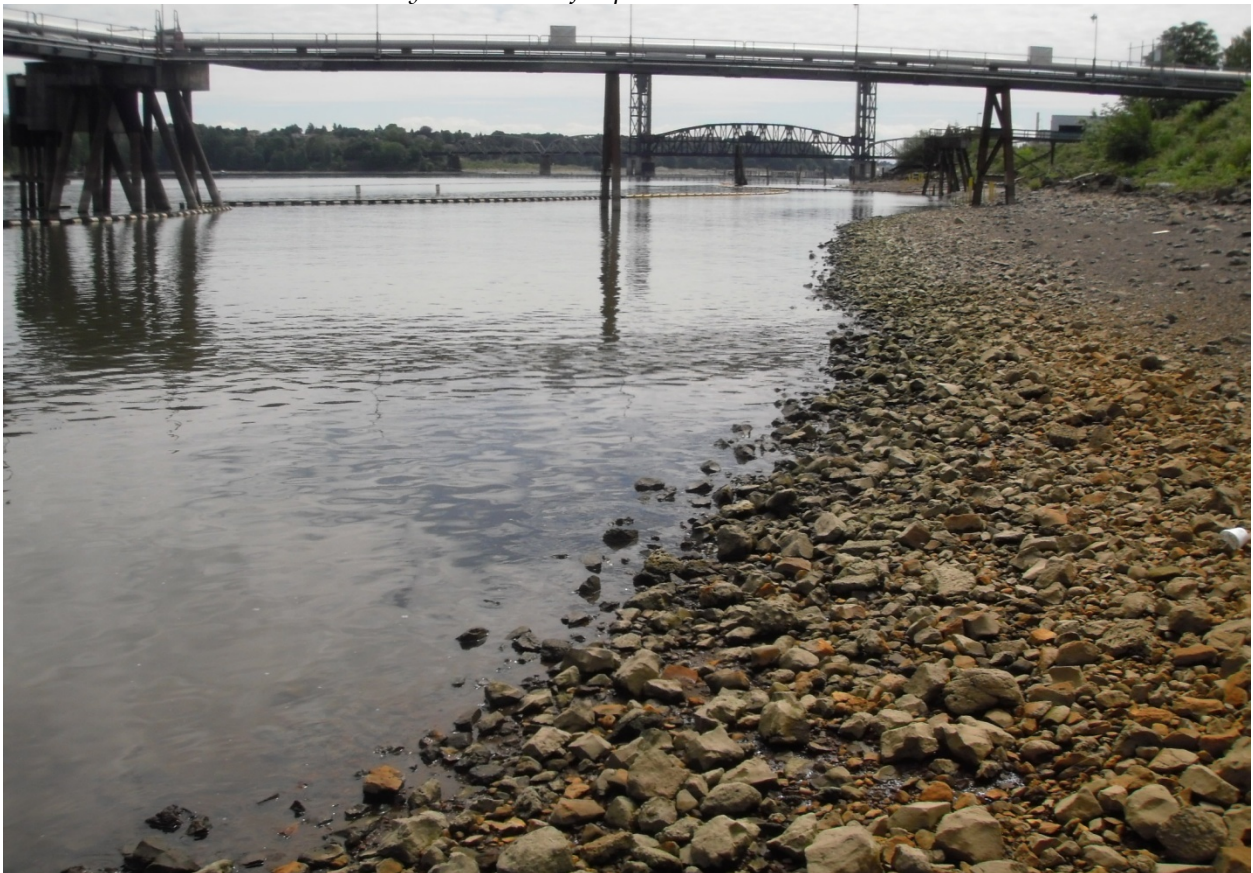
No sheen is evident in or around the cap area. Photo 3 shows the water surface and shoreline immediately downriver of the sediment cap.

Photo 3 — *Conditions immediately downriver of cap area (6/17/13):*
